# CONCRETE MASONRY

**CMU Historic  
Preservation: Kahn  
Bath House**

# *Kahn Bathhouse*

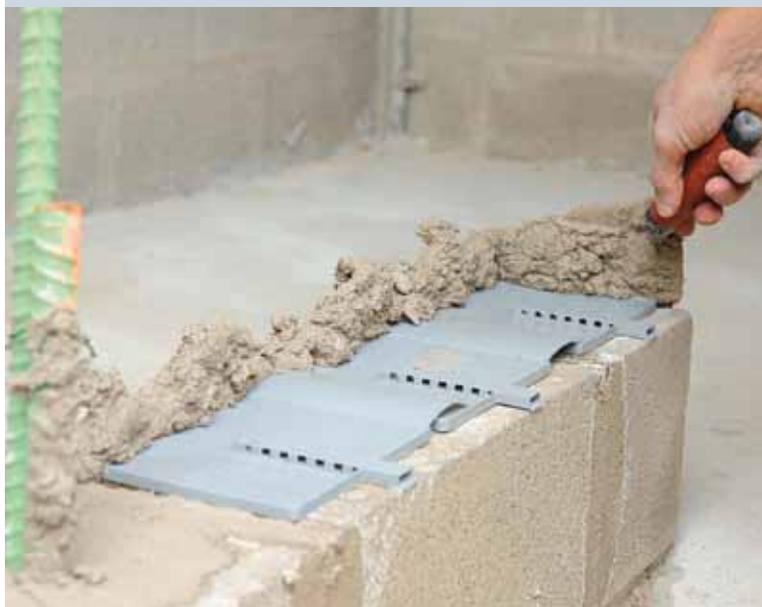
**Correcting Kahn’s flashing omission with hidden 2010 technology, one of Cavalieri’s masons grouts the flashing system into place.**

Since water had caused the Bath House's downfall, Michael Mills specified a couple of technologically advanced products (invisible, of course) to address those moisture-control problems. At the bases of the walls exposed to roof-runoff, Mills used a uniquely engineered proprietary flashing system. It consists of tough, lightweight "flashing pans" that are laid atop the first above-grade course of CMU and grouted into place. They intercept the water as it runs down the CMU's cores and expel it through integrated, unobtrusive drainage spouts. To capture mortar droppings, proprietary feather-light

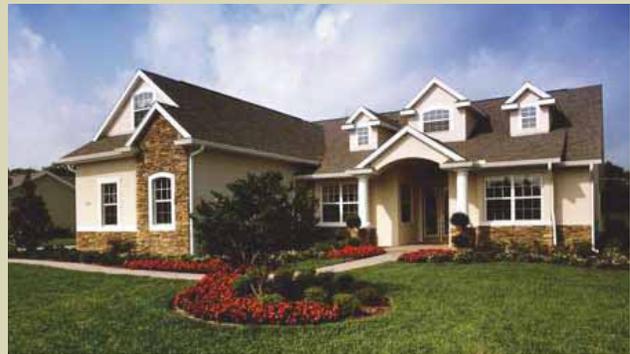
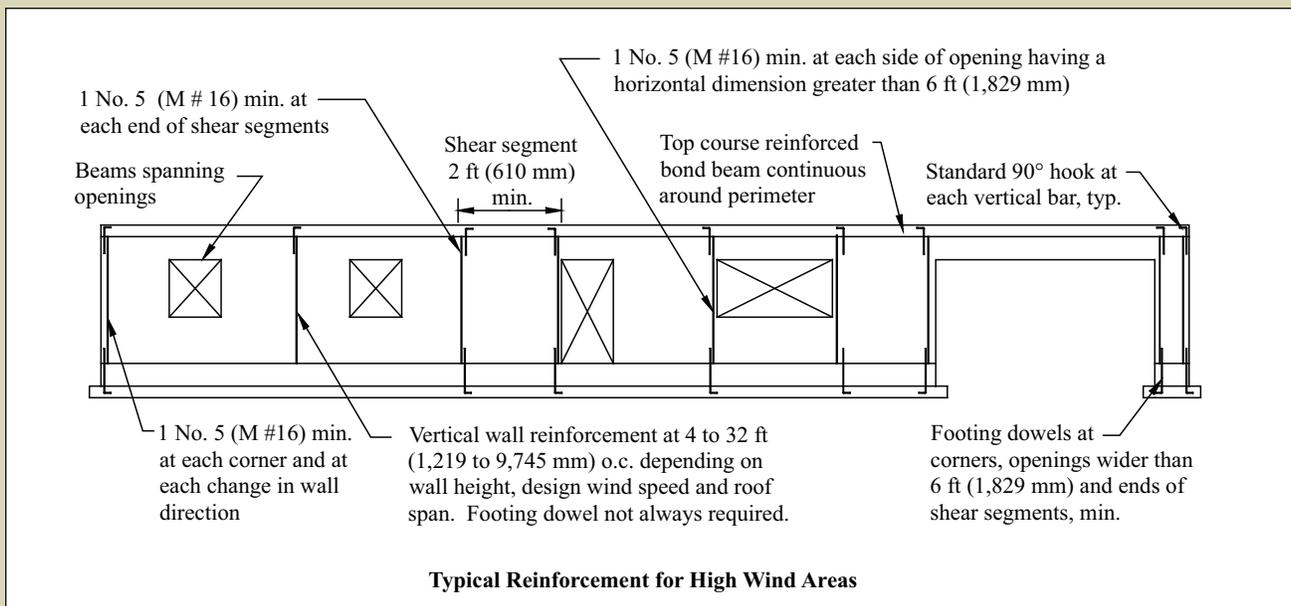
In addition, a continuously reinforced bond beam around the entire perimeter of the building with vertical reinforcement at strategic locations in the wall is needed to resist design loads. See the figure for recommended minimum amount of reinforcement.

A primary goal for buildings subjected to high winds is to maintain a continuous load path from the roof to the foundation. This allows wind uplift forces on the roof to be safely distributed through the walls to the foundation, where they are dissipated into the ground. If one part of the load path fails, or is discontinuous, building failure may occur.
